CASE STUDIES

**HIGH VELOCITY COOLING
UNIT TECHNOLOGY**

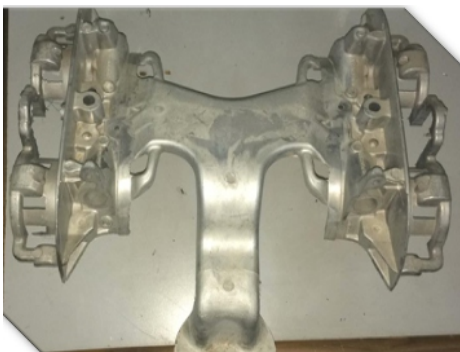
Cap Cam Shaft

Part Name	Case Transmission
Tonnage	530 Ton
No. of Cavity	2 no.
Material	Aluminium
Problem Area	Shrinkage Porosity
Result	Porosity reduced to a great extent [12% to 7%]

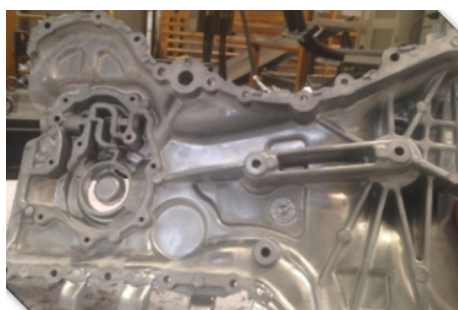
Part Name	Timing Case Cover
Tonnage	530 Ton
No. of Cavity	1 no.
Material	Aluminium
Problem Area	Shrinkage Porosities
Result	Porosity reduced to a great extent from 35% to only 6%
